Feasibility Study
Disposal of Dredged Material
Morris Cove, New Haven Harbor

Disposal Area Monitoring System Damos

Contribution 36

A FEASIBILITY STUDY OF THE
DISPOSAL OF DREDGED MATERIAL AT
MORRIS COVE, NEW HAVEN HARBOR

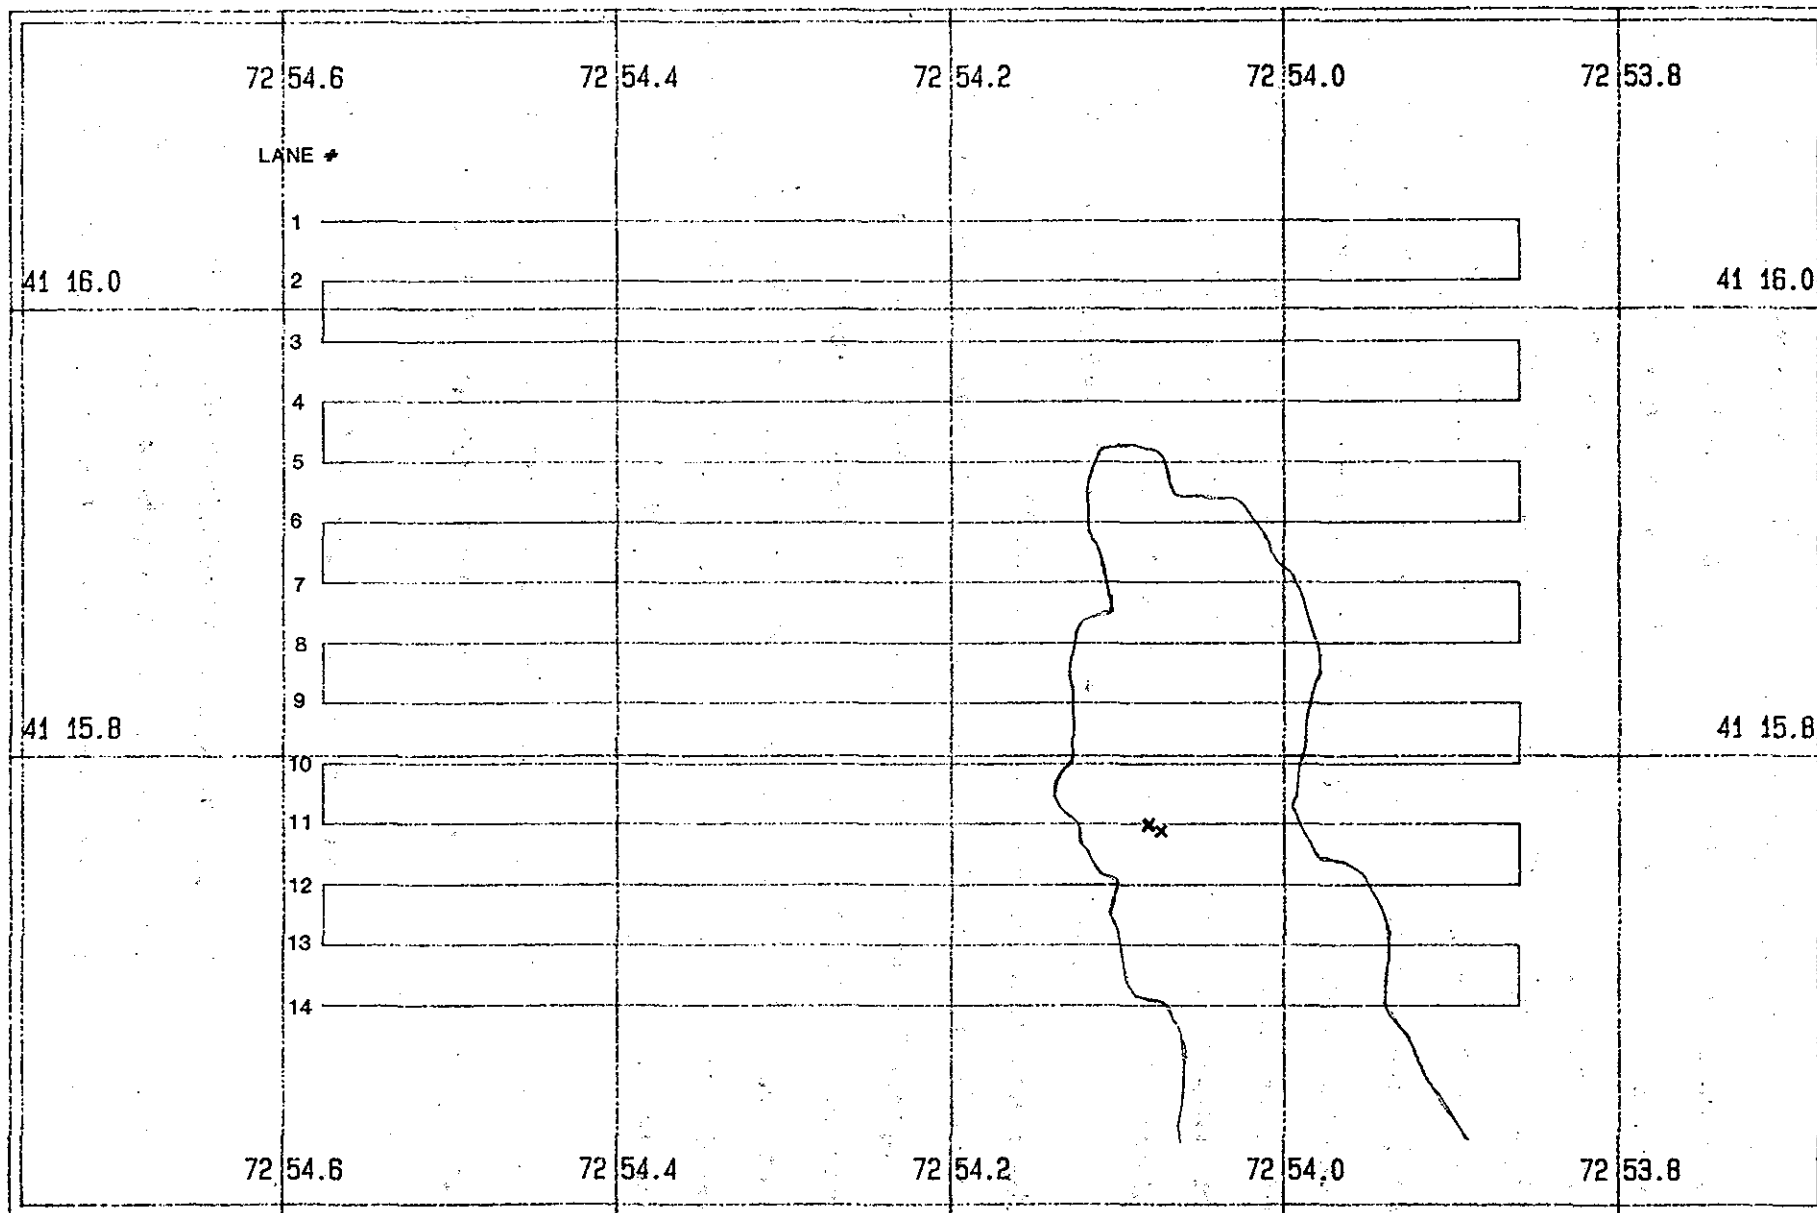
Figure 3.0-1. Dye Study Survey Lanes

The dye was released at a continuous rate from a small skiff moored in the approximate center of the borrow pit (see Fig. 3.0-1). Release of the dye commenced at 1600; approximately 1 hour after low tide. For this study, a 5% solution of rhodamine WT dye was pumped at a rate of 0.75 gal/hr. ($7.886 \times 10^{-7} \text{ m}^3/\text{sec.}$)

began, dye was detected and subsequently determined to be moving in a northerly direction with the incoming tide, despite a very strong northerly wind. As a result, a dye survey was established with east-west lanes separated by 50m so that transects of the plume could be made. This dye survey setup showing the approximate dye release location is shown as Figure 3.0-1.

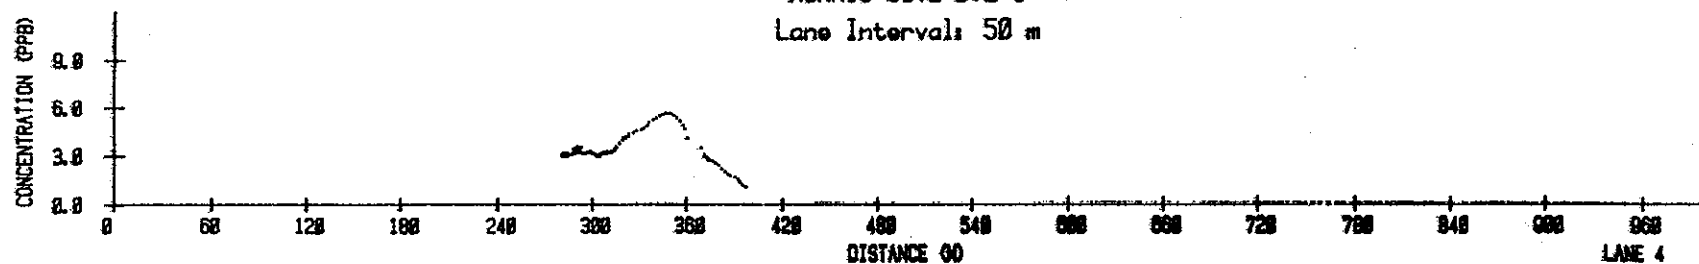
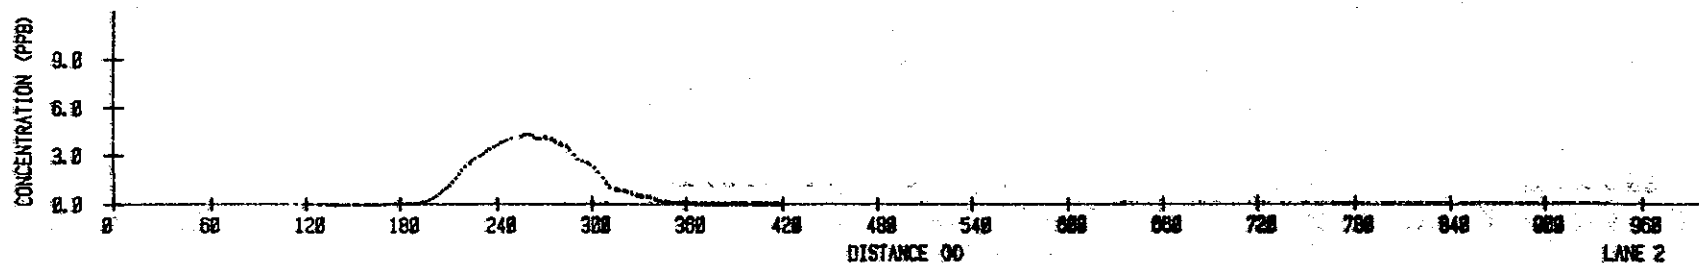
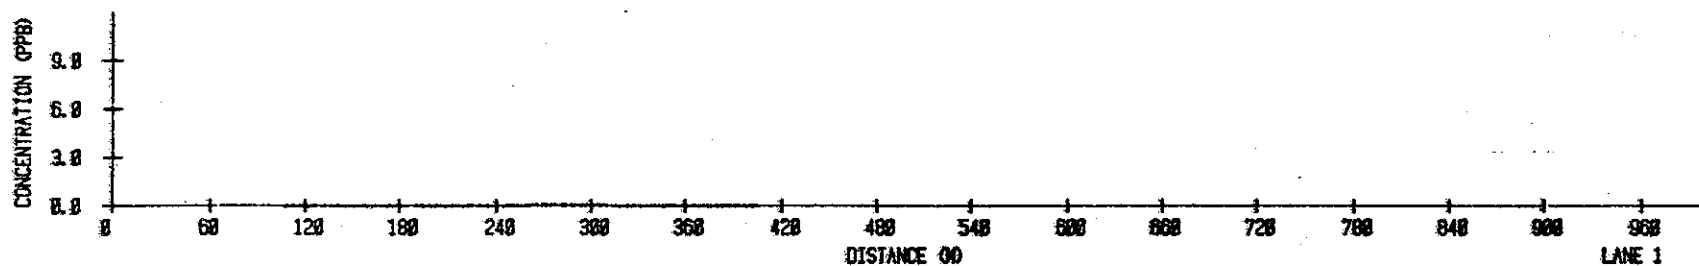
Figure 3.0-2. Dye Concentration

Profile plots of observed dye concentration as a function of distance along a lane from west to east are shown in Figures 3.0-2 thru 3.0-7. Figure 3.0-2 shows the profiles for the Series 1 northerly transects. At this early stage in the dye study it can be seen that no data was observed as far north as lane 1 and that the maximum concentration of approximately 6.0 ppb was in lane 4. Lane 4 is approximately 50m north of the northern edge of the borrow pit.

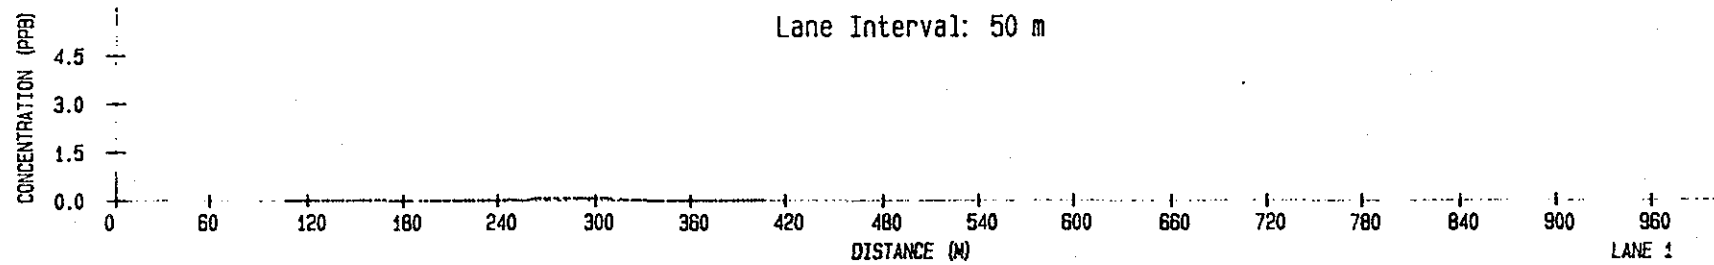
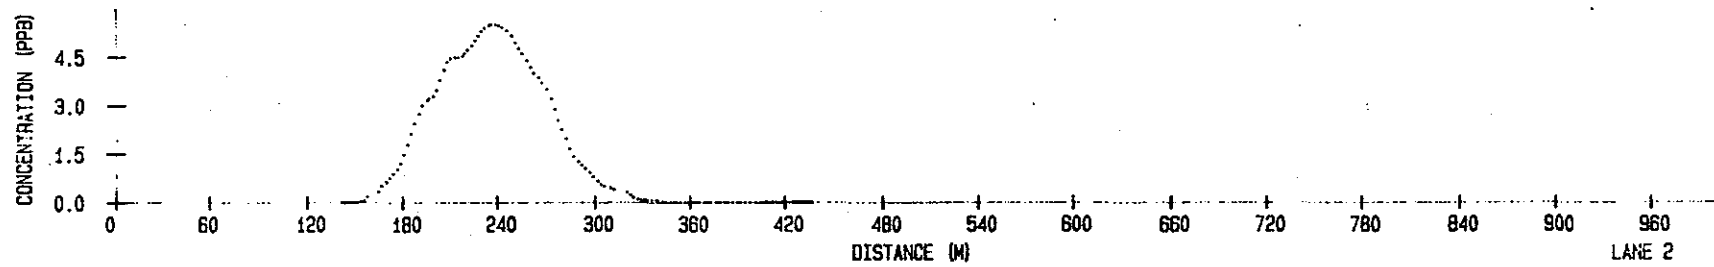
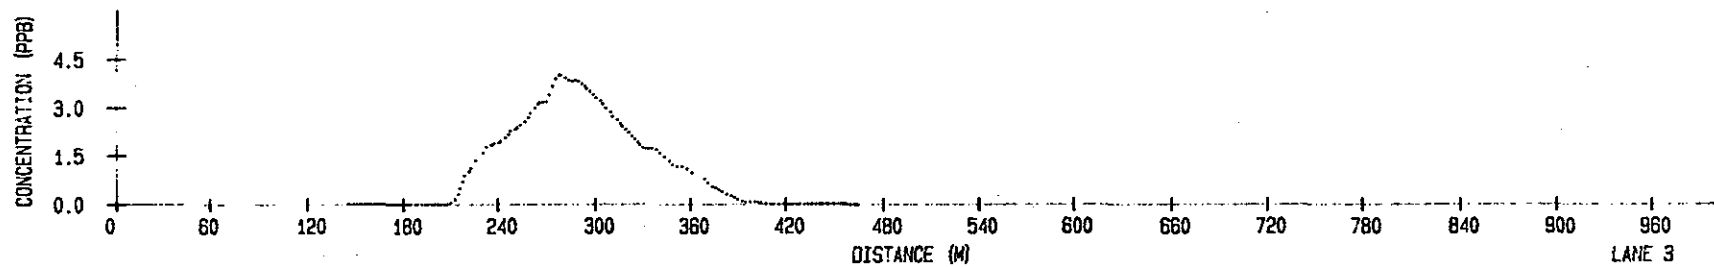
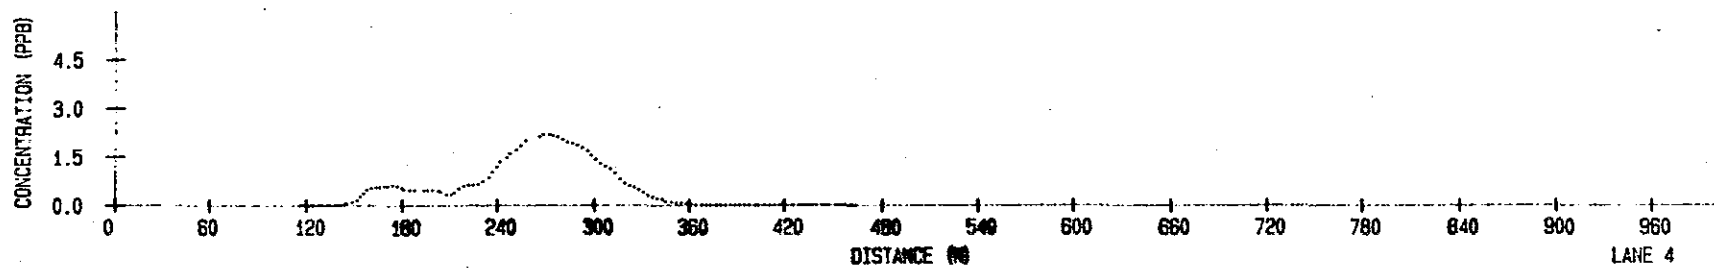
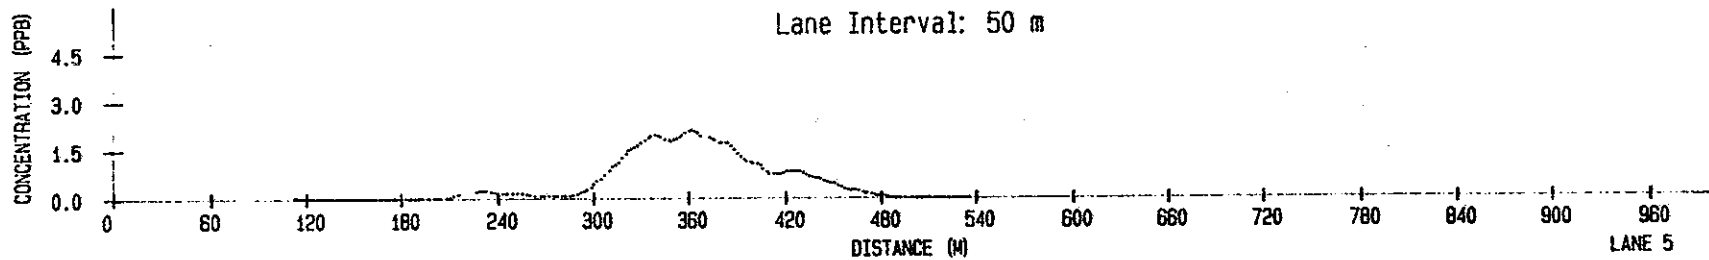
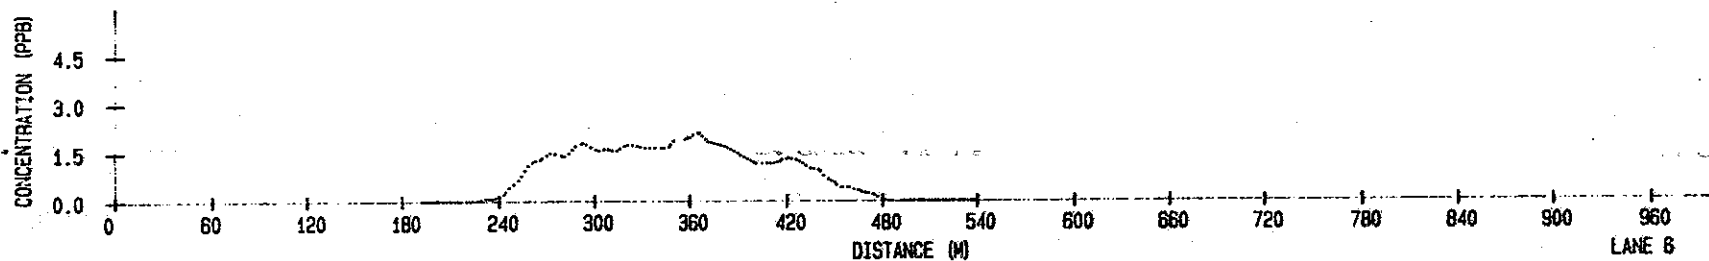
Profiles of Series 2 southerly transects (Figs. 3.0-3 thru 3.0-5) show a maximum concentration of approximately 6.0 ppb in lane 2 with gradually decreasing maximum values for lanes 3 thru 8. Finally, Series 3 transects show a maximum concentration of only about 2 ppb in lanes 5 and 6 (Fig. 3.0-6, 3.0-7).

center of the borrow pit, the dye was carried in a northerly direction by tidal currents. Upon contact with the northern edge of the borrow pit, the dye appears to have been driven upwards towards the surface resulting in maximum concentration being observed in lanes 2 and 4. The edge of the borrow pit is approximately beneath lane 5.

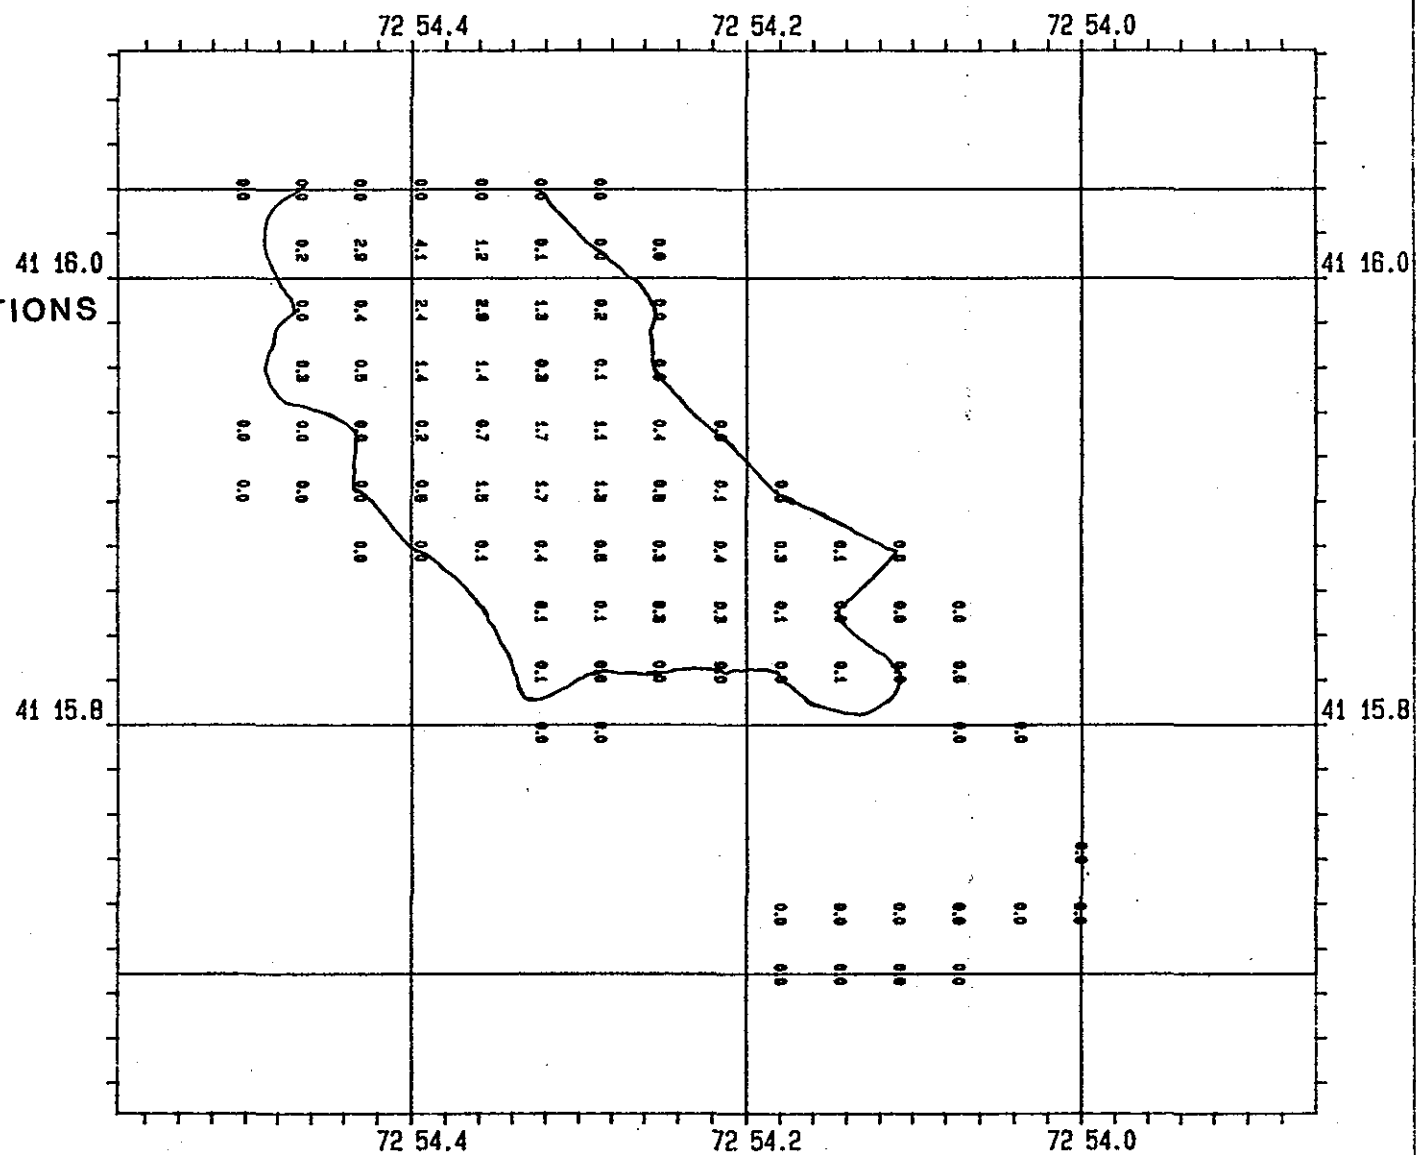
FIGURE 3.0-8

Since Series 2 transects contain the greatest number of lanes with the highest concentration of dye, these data were used to construct a dye concentration contour map of the study area shown in figure 3.0-8. This contour map dramatically shows that maximum dye concentration values were located at the northwest end of the study area, slightly north of the northern edge of the borrow pit. Therefore, these data indicate that despite the presence of a strong northerly wind, the dye was propelled along the bottom by the incoming tidal current until contacting the northern edge of the borrow pit. When this contact was made, the dye was then forced upwards as well as northward under the influence of the tidal currents.

Using this contour map, it is possible to estimate the percentage of the dye released which was detected by the fluorometer. Assuming that the dye measured by the fluorometer is representative of a column of water 10 feet (3.05m) deep, then 83.4% of the available dye was sampled as part of the Series 2 transects. While the exact percentage of dye seen is not important, the relative magnitude of this number indicates that this sampling technique was valid in determining the current regime in the borrow pit area.

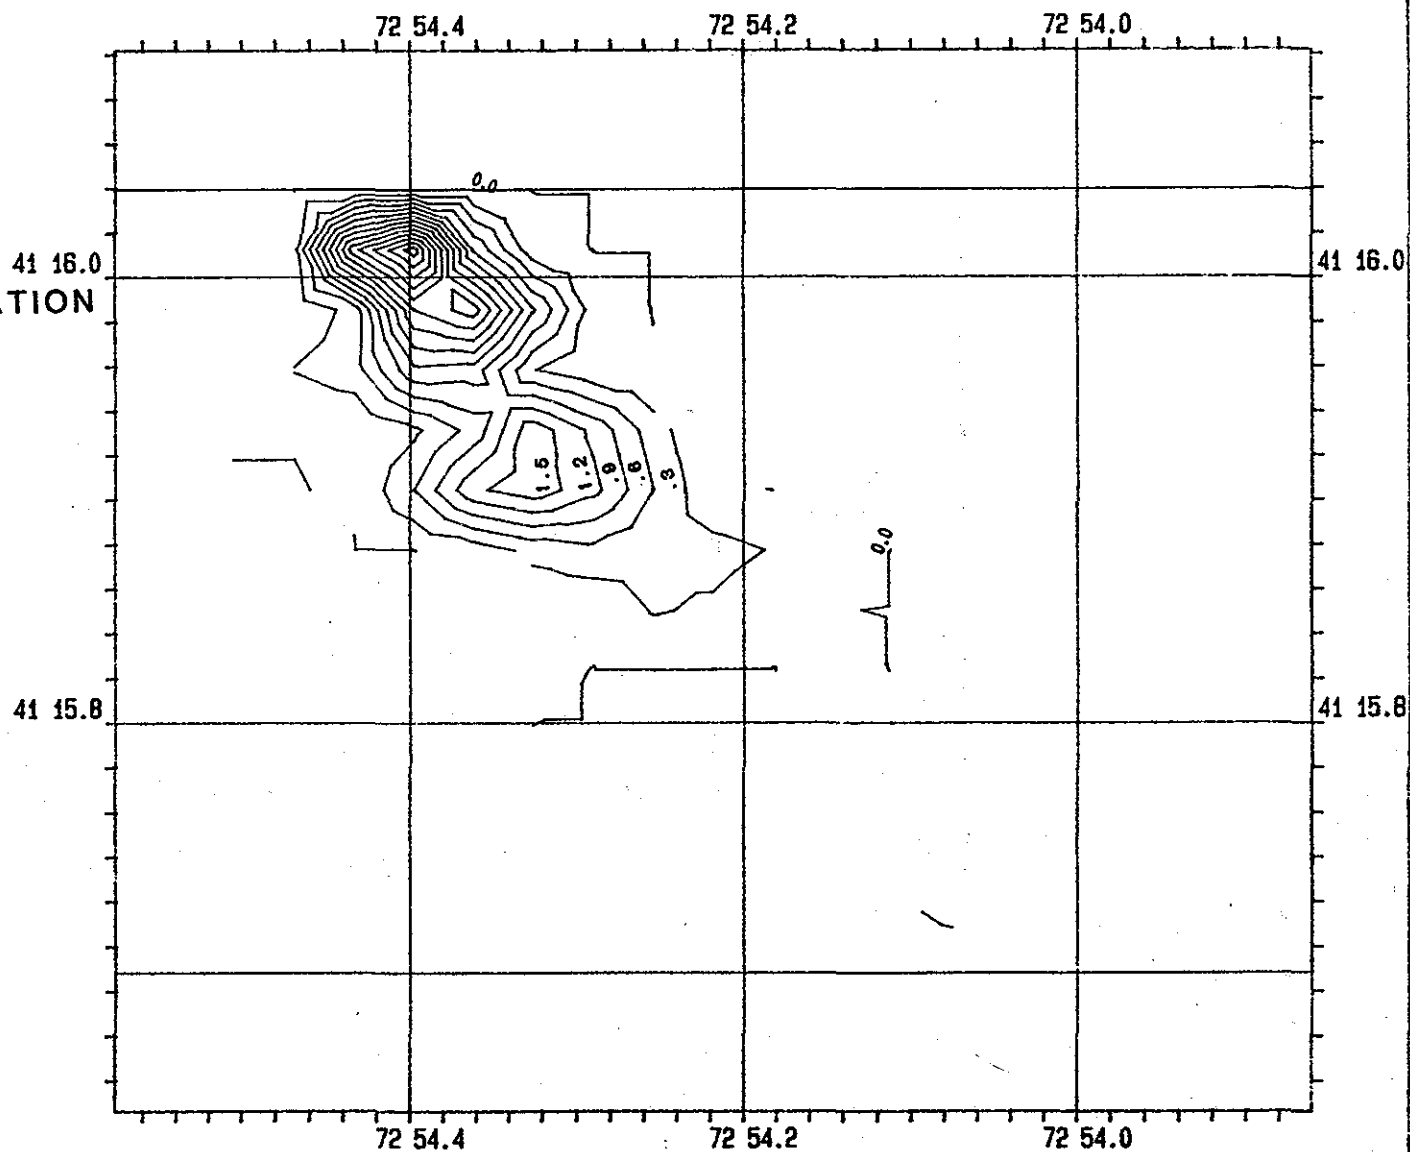
FIGURE 3.0-9

MORRIS COVE
DYE CONCENTRATION
CONTOURS

CONTOUR INT.
0.3 ppb
